# NAVAL SHIP RESEARCH AND DEVELOPMENT CENTER

## THE STRUCTURAL BEHAVIOR OF GLASS PRESSURE HULLS

STRUCTURES DEPARTMENT  
RESEARCH AND DEVELOPMENT REPORT

Report 3863

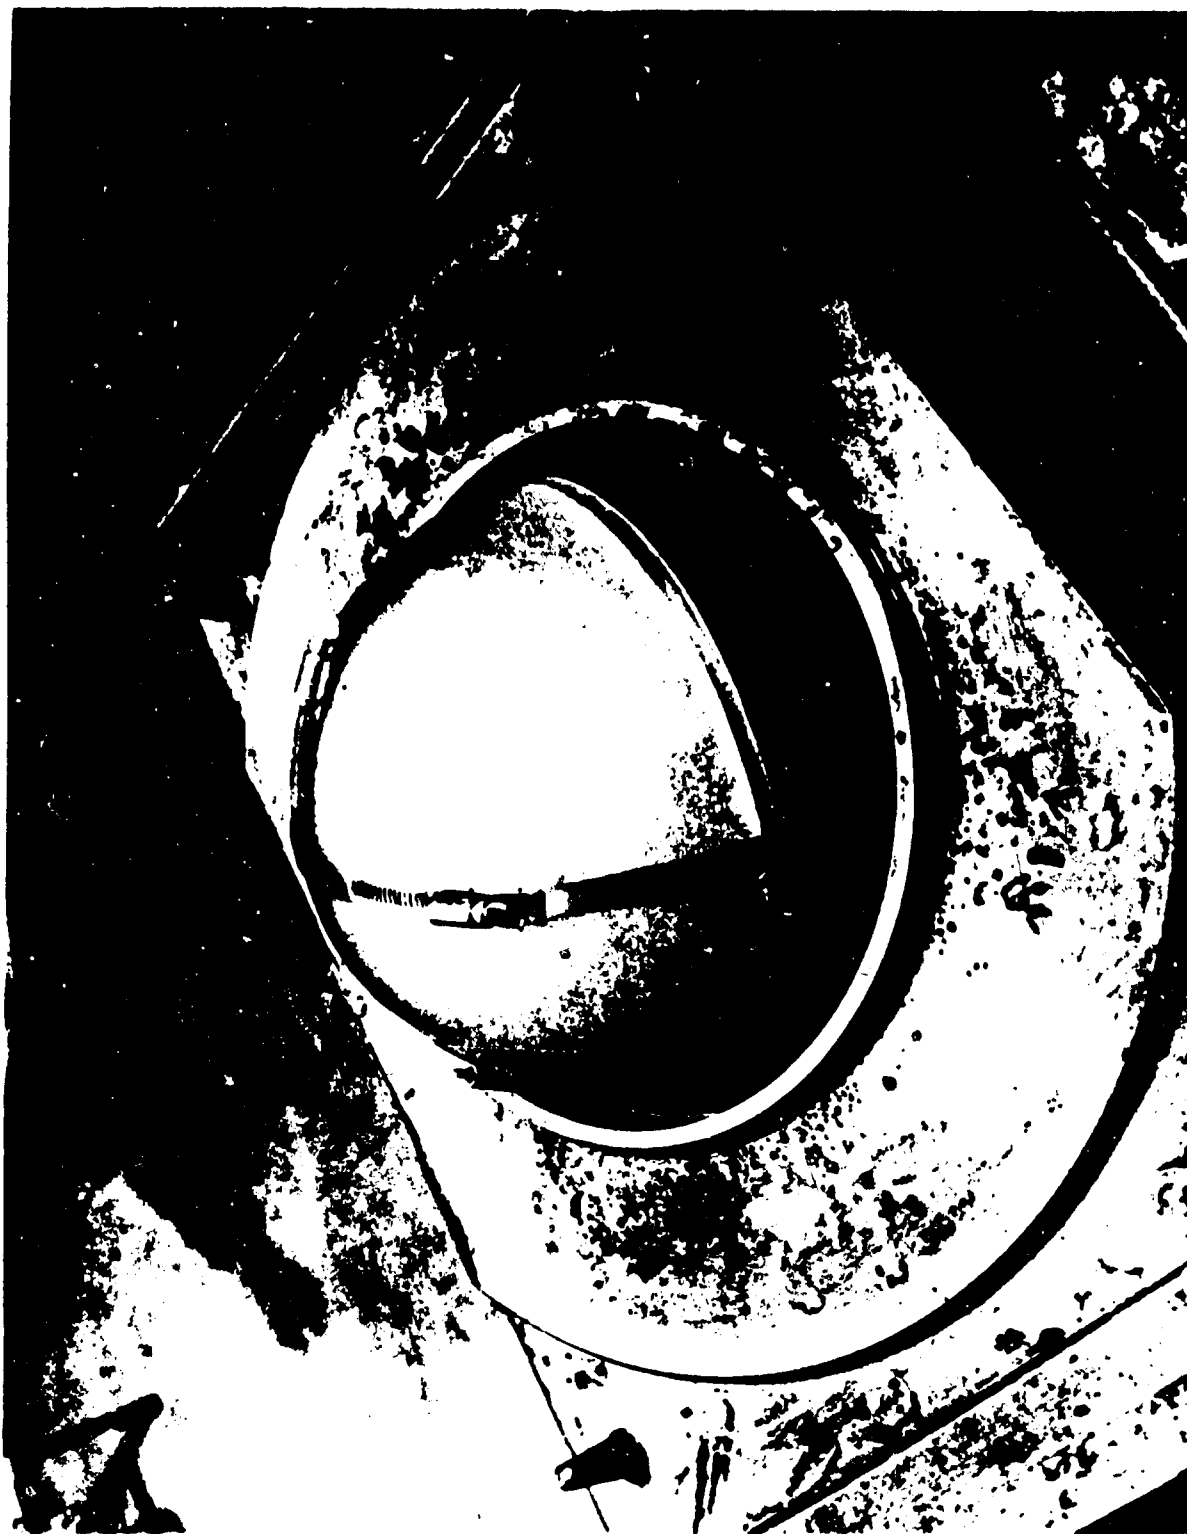
Figure 13 - Model in Test Facility

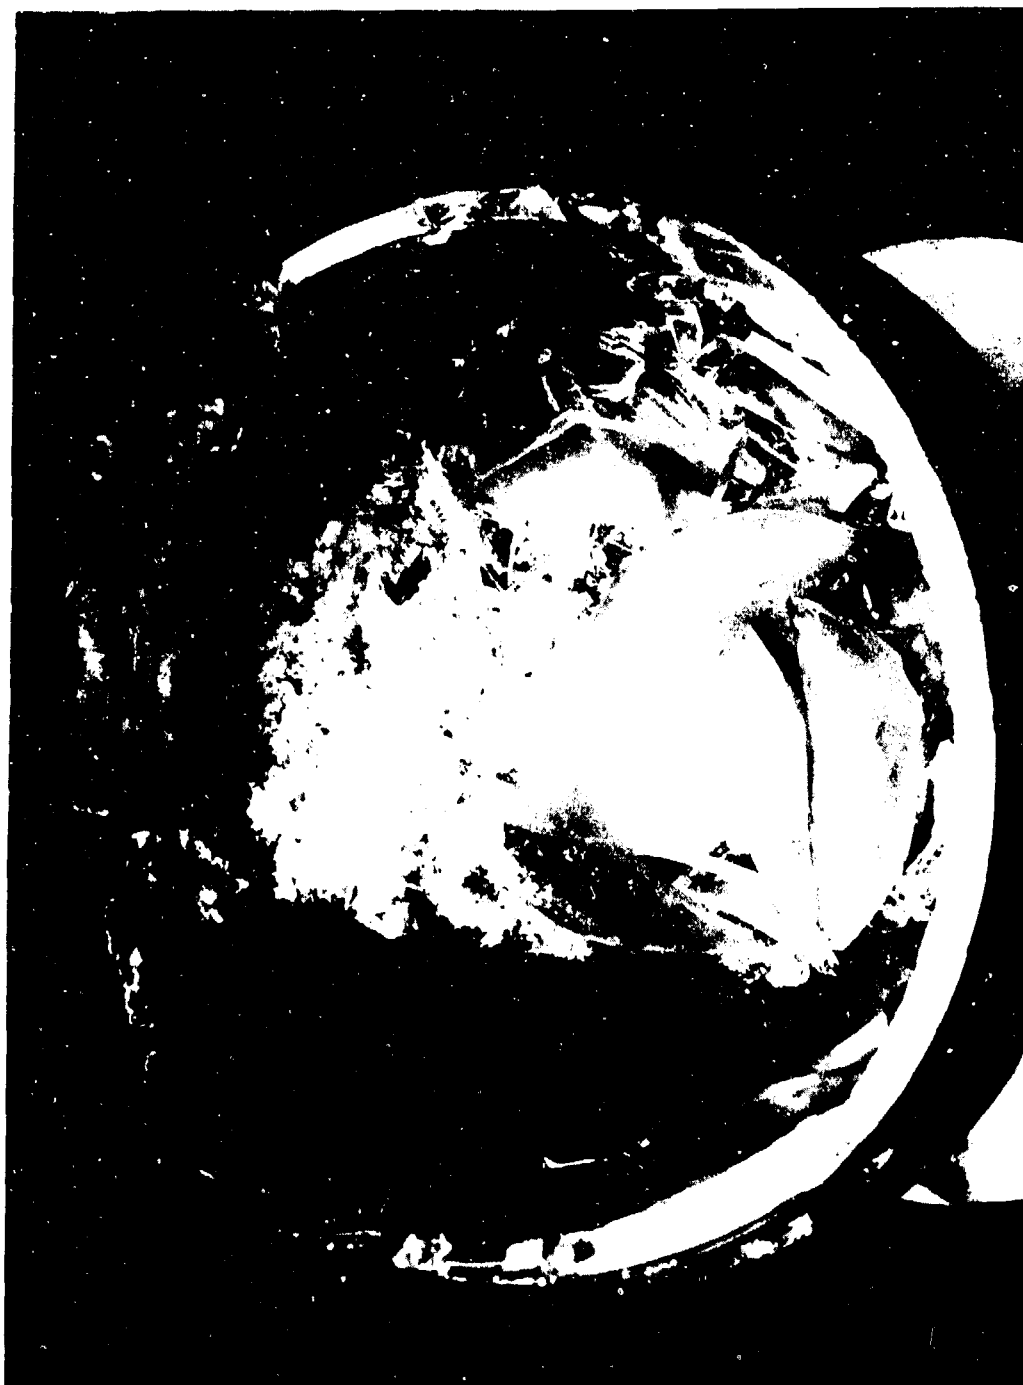
Model 19a - HGS-14

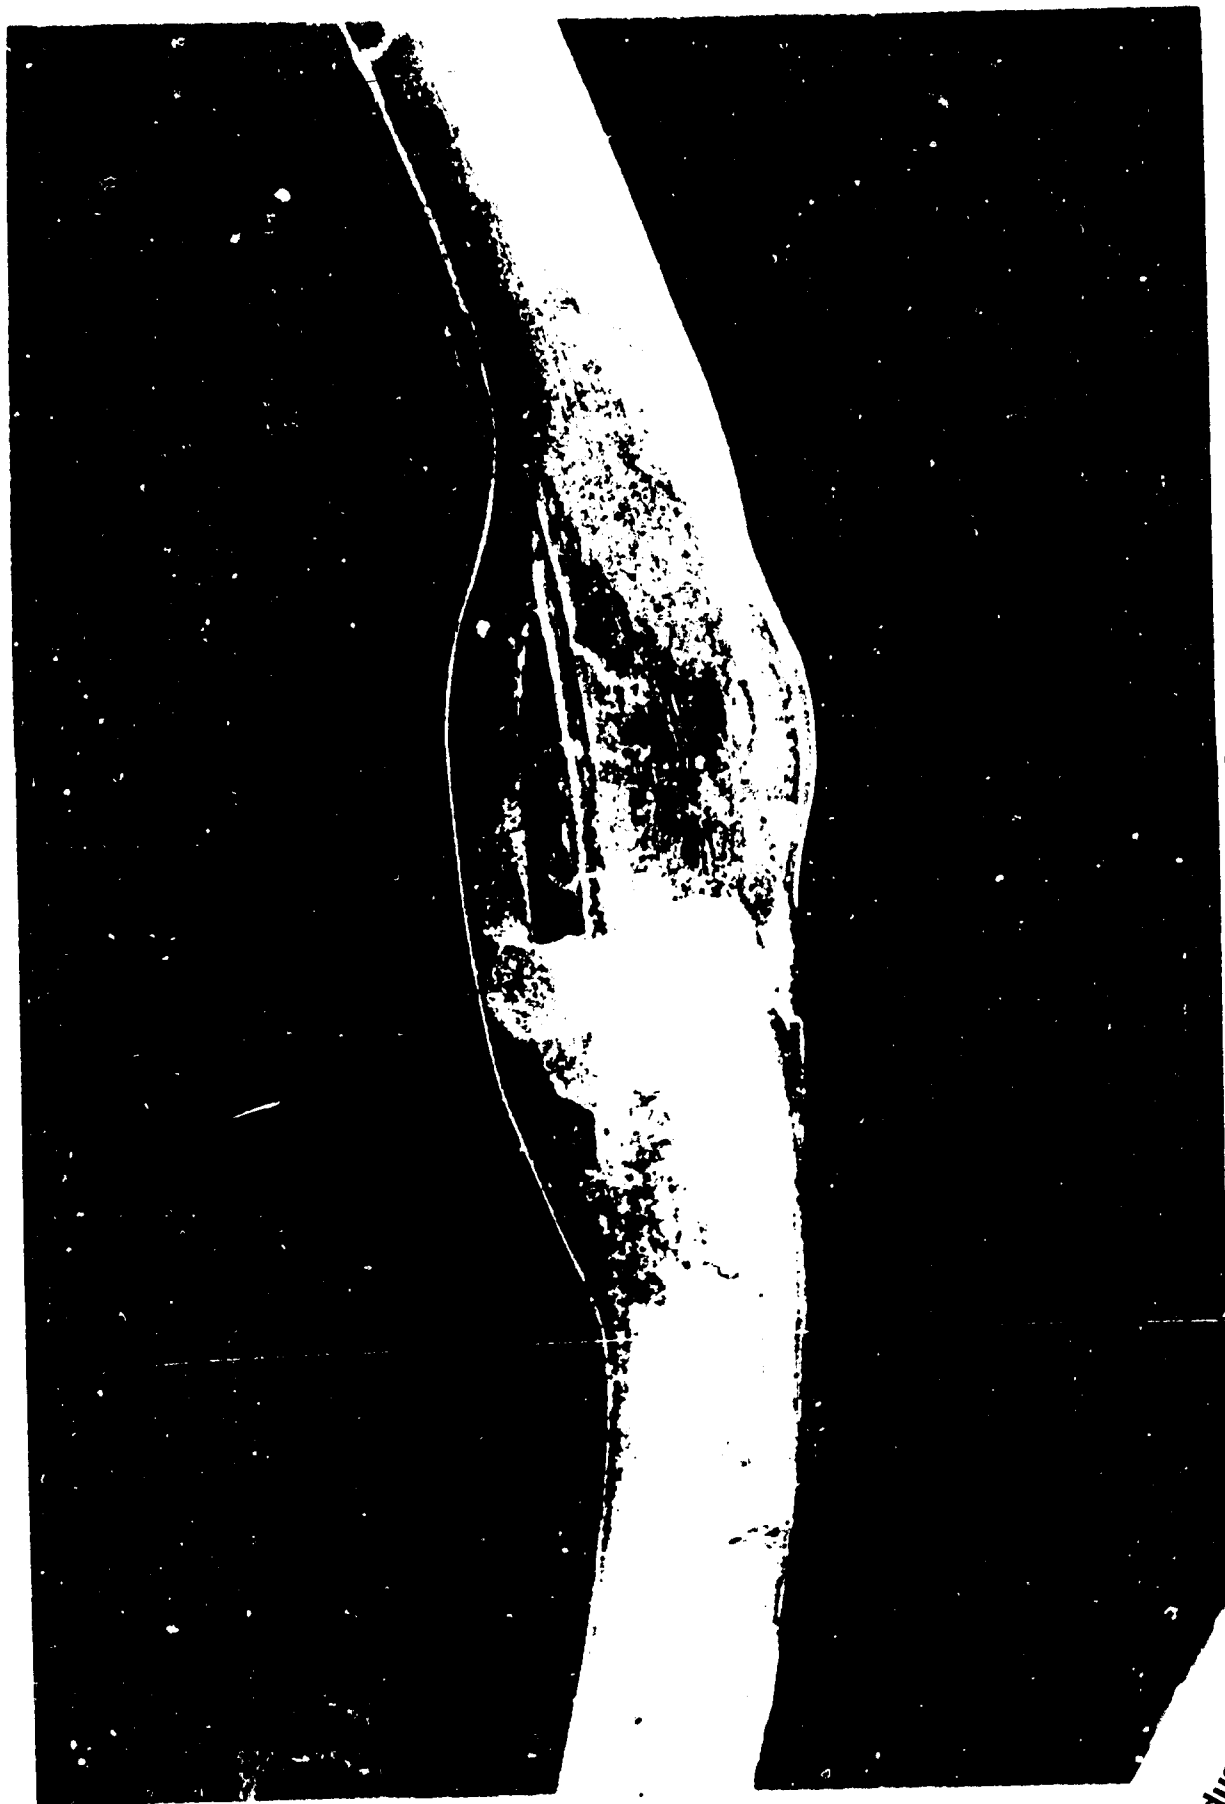
Figure 19b - HGS-17

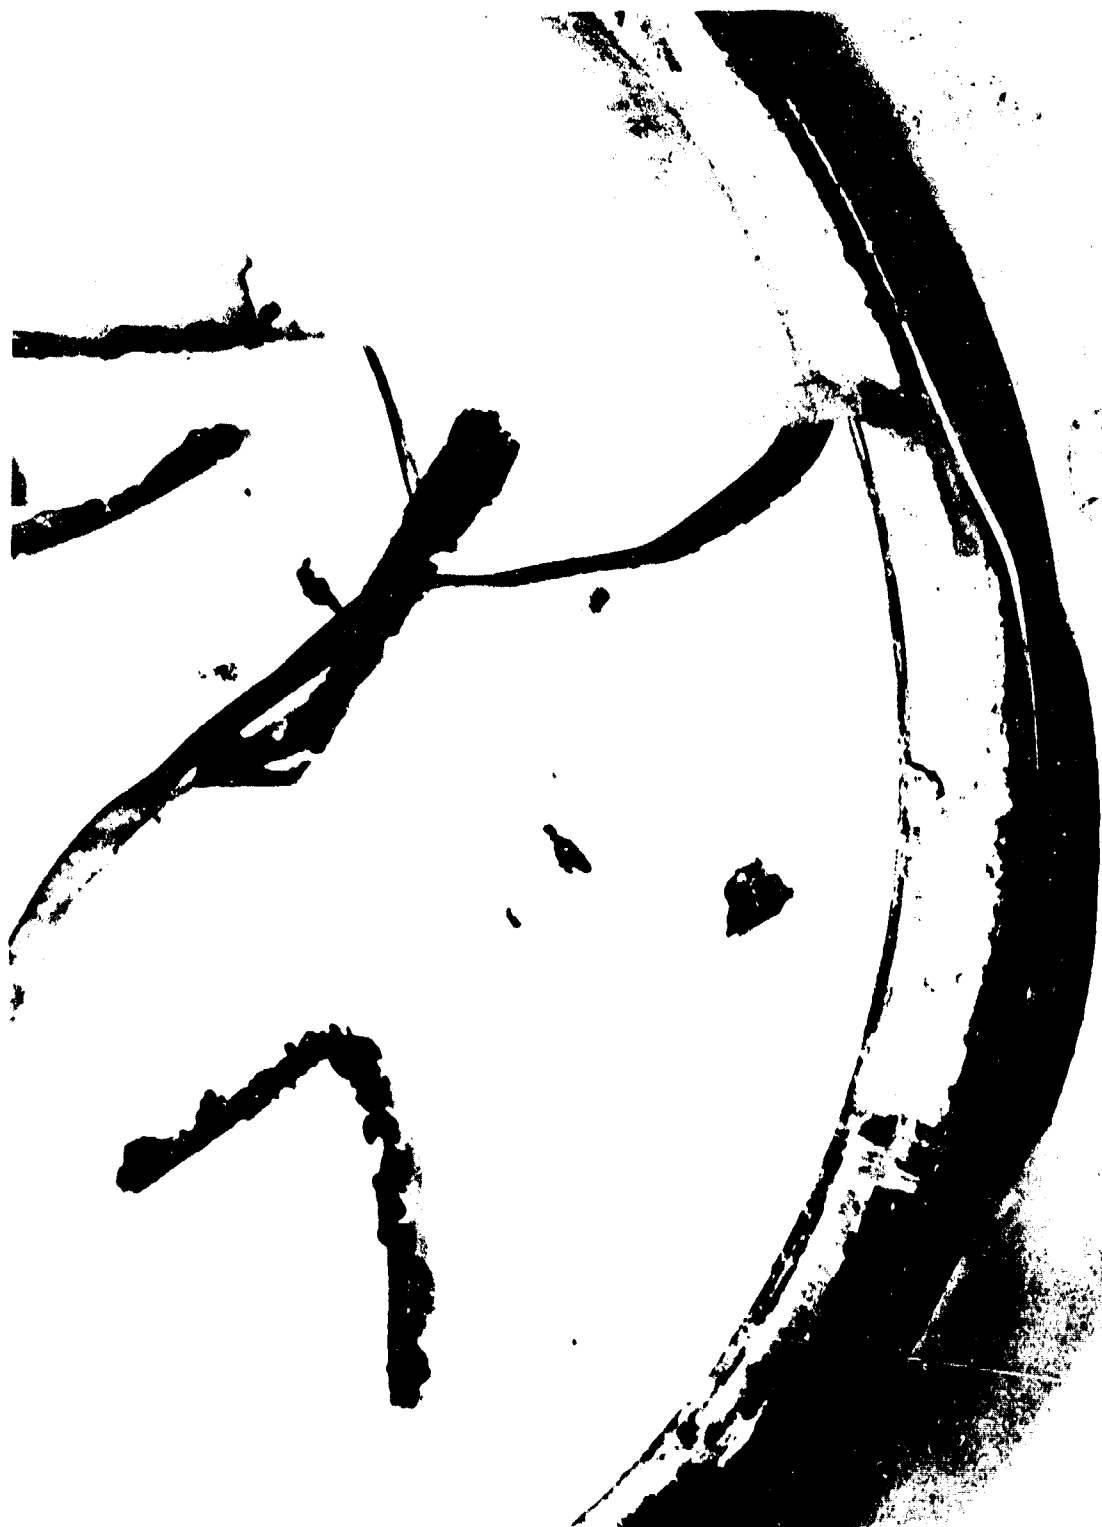
Figure 19c - HGS-3

Model HGS 3 survived a total of 2380 cycles to 10,000 psi. The last inspection of the model was after 1100 cycles at which time no damage was apparent except for some pits on the inner and outer surfaces of one hemisphere. The model failed on the 2380th cycle, while pressure was being applied at 9000 psi.

The failure of Models HGS 1, 2, and 3 is believed to have occurred at the joint. In each case the fractured glass in the titanium ring was in the form of very fine white powder that had a considerably finer grain than all other pieces of fractured glass. A photograph is shown in Figure 19. The average bearing stress at 10,000 psi for this geometry is 72,000 psi. Since the residual surface compression on PPG 1080 Na<sup>+</sup> models
